Advice paper

# Making the case for facility revamping

How to initiate, prepare and manage facility redevelopment projects

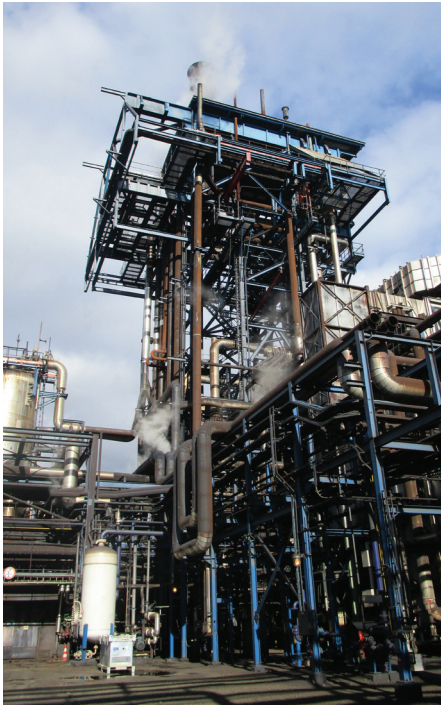
## 5.1 Renovating a chemical process tower

The 10m by 10m steel tower housing a crucial process installation at a chemical plant was due for renovation. The structure was 50 years old and showed severe signs of wear, mostly as a result of year-round exposure to aggressive substances. A budget was secured for a thorough renovation, but there were no detailed drawings of the original structure, and additional equipment and elements that had been tacked on to the structure over time could possibly be compromising its strength and long-term viability.

A comprehensive measurement campaign was therefore carried out to clearly identify any weak spots before a cost-effective proposal for renovation, indicating the parts needing repair or replacement. The project also had to be carried out without shutting down the process. Consequently, scenarios and procedures were developed to dismantle and assemble parts without disturbing the process. This involved temporarily attaching and securing cables and ducts while taking measures to comply with the stringent site safety standards. Before this, tests were carried out on one level of the tower to help finetune scenarios and procedures where necessary.

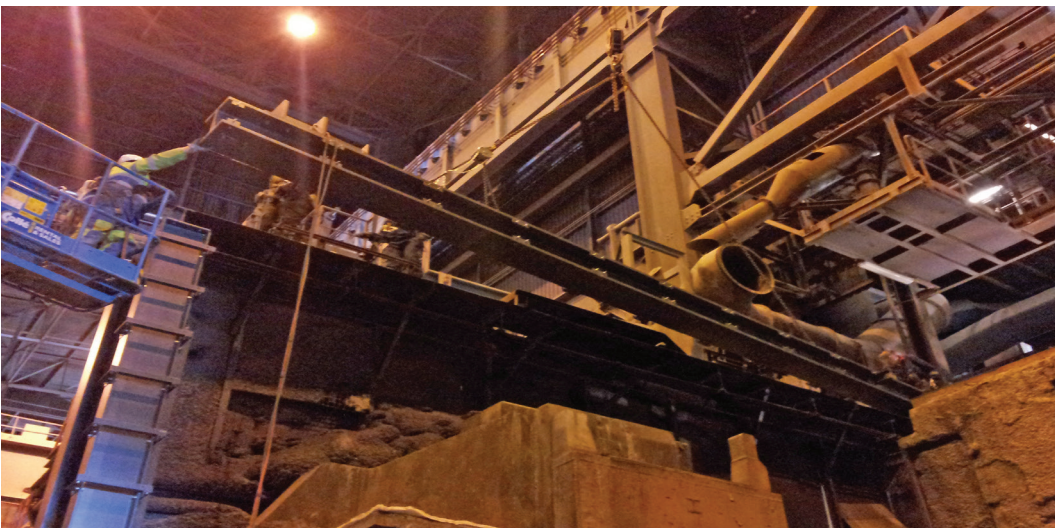
## 5.2 Design weakness identified and corrected

A severe problem was detected in a transportable exhaust hood at a stainless steel melting shop. The hood, which rests on a trolley running over two rail beams, is positioned above the casting ladle to allow 1500°C hot exhausts produced during the heating process to be expelled. The trolley wheels showed signs of wear, and on further inspection the rail beams were slightly bowed. This was alarming, since it was an issue that the supplier had insisted was addressed a year earlier when some small cracks in the rail beams were repaired. Apparently, this hadn't prevented the phenomenon from happening again. It became clear that it would not suffice to simply replace the beams.

A project was launched to find the root cause of the problem. The entire exhaust hood, of which no up-to-date drawings were available, was carefully measured to determine its weight. In addition, the exhaust hood and beam designs were analyzed against the operational conditions of the installation, particularly the high temperatures.

The analysis revealed that the entire structure weighed no less than 60 tonnes, in part due to elements that for various reasons had been added over the years. In addition, the beams, composed of welded flange plates, proved to be ill-suited to withstand the temperature fluctuations.

Eventually, the 240 kg/m welded beams were replaced by 360 kg/m rolled beams, with the addition of heat radiation protective shields. Two damaged columns were also renovated, and new crane wheels of greater strength and better heat resistance were installed.

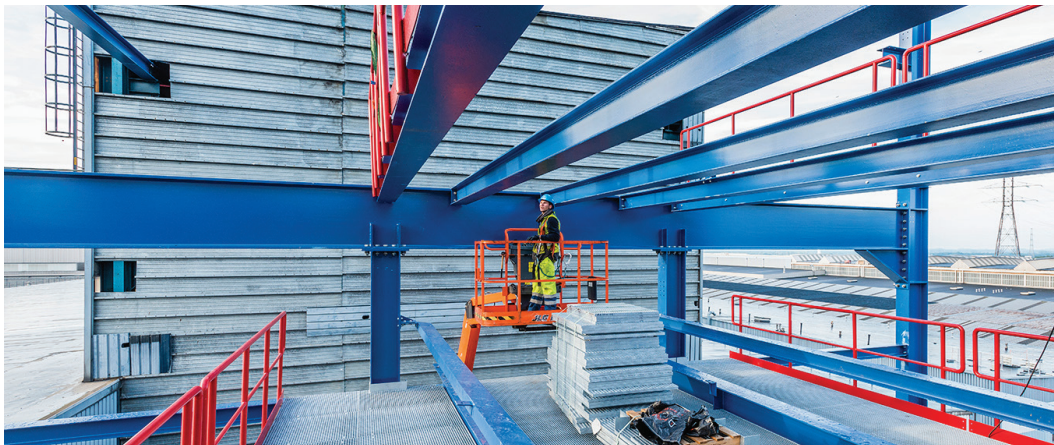
### 5.3 A touch of inventiveness to reduce risks

A building needed to be extended by about 40 metres to accommodate an updated stainless steel production process. However, production downtime had to be reduced to a minimum, meaning that there was only a two-week timeframe available during the Christmas break to connect the existing building with the new structure. Initially, the idea was to remove the existing roof to allow a hydraulic mobile crane to be used for the connection work. But this would risk substantial delays in the event of unfavourable weather conditions.

An unconventional alternative solution was used instead, involving the installation of an additional overhead crane in the connection zone. This meant that the roof could remain undisturbed and that the weather would not impact the exercise.

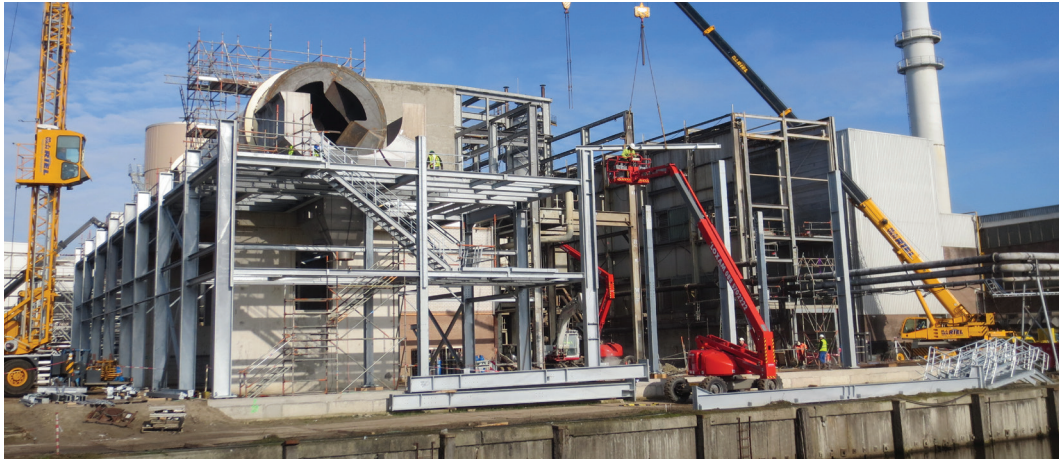
### 5.5 Extending a sugar beet-washing line

A sugar producer's beet-washing line needed to be extended to allow a 25% capacity increase. The washing line is the beating heart of the factory during the 'campaign season', when the sugar beets are harvested. Incoming beets are carefully washed in several stages using a fast and highly-automated process which must be carried out with great precision to ensure that not the tiniest bit of dirt remains.

It was decided to optimize the use of space by building additional structures within and around the existing building, making for some tough technical and organizational challenges:

- The existing structure was carefully measured to allow the design to be optimized, and to prepare for the complex engineering work, taking into account the structural vibrations induced by the washing equipment.
- The measurement campaign was carried out in the middle of the harvesting campaign, making good communication with the operations manager essential.
- Connecting the older building with the new extension imposed very tight tolerances on the manufacturing process.
- Detailed construction scenarios helped workers to successfully deal with the limited manoeuvring space.
